CONTINUING ELIGIBILITY INSPECTION (CEI) REPORT
FOR FLOOD CONTROL PROJECTS

1. Project Name: Kahoma Stream FCP for FY03

2. Date of Inspection: October 29, 2002

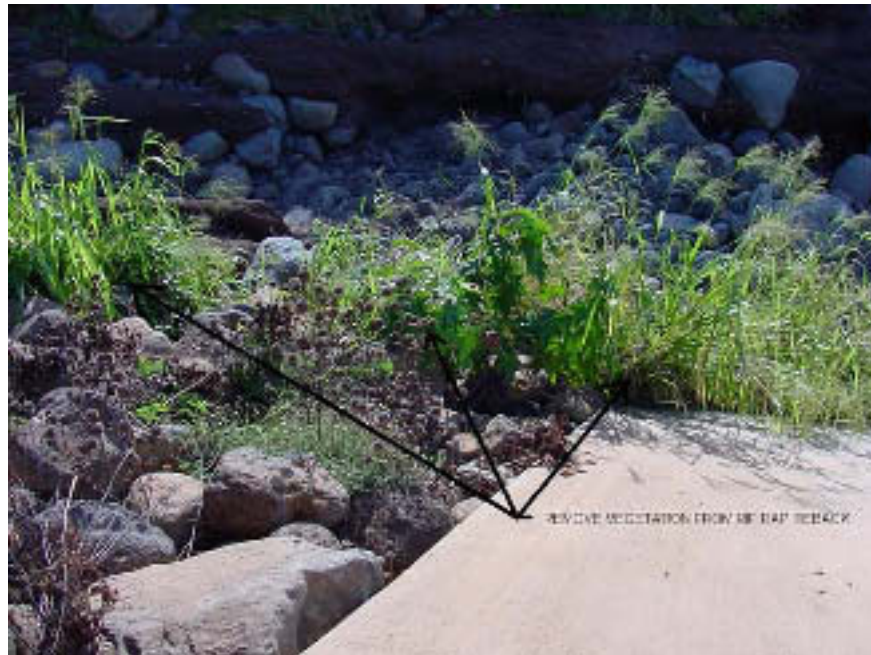
a. Sta. 61+50, remove vegetation from debris basin.

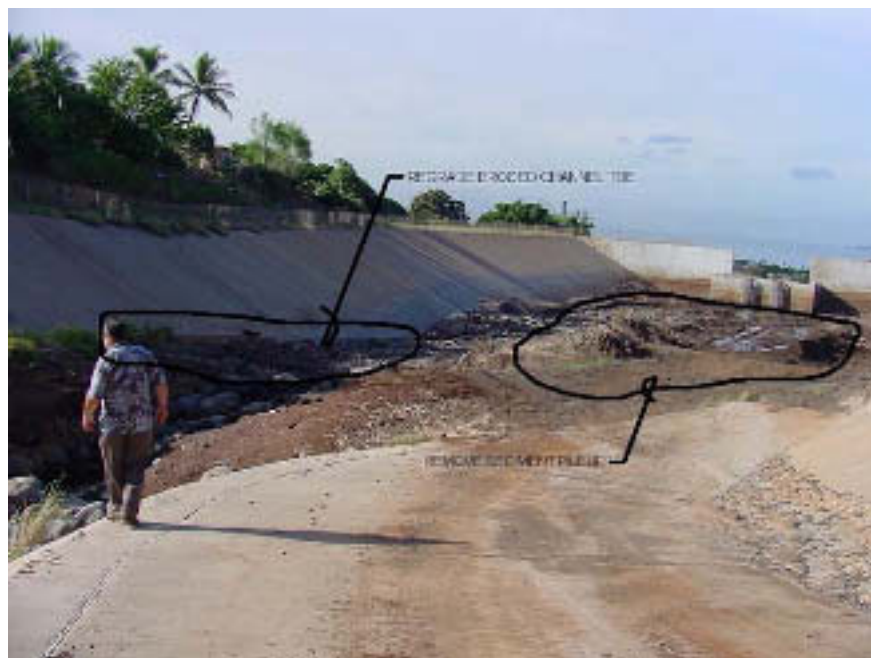
b. Sta. 60+00, debris basin, re-grade eroded channel toe and remove sediment pileup from basin.

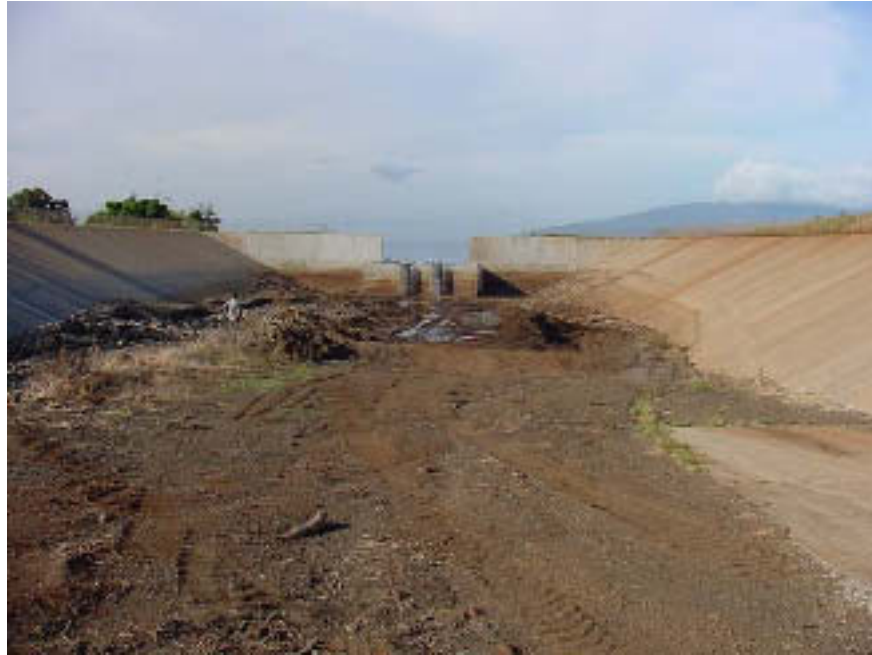
c. Sta. 59+00, debris basin, overview.

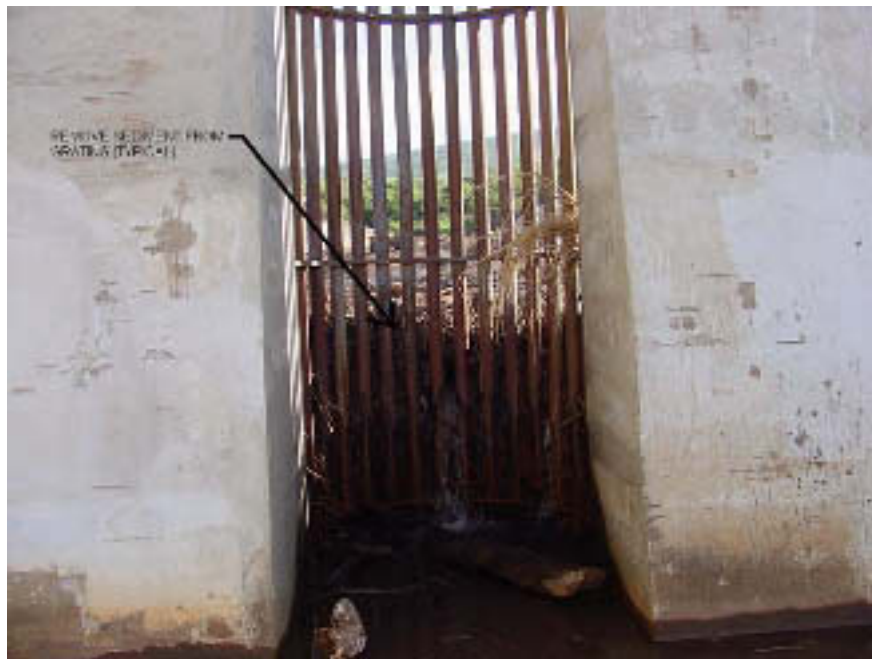
d. Sta. 55+00, debris basin, remove sediment from grating (typical).

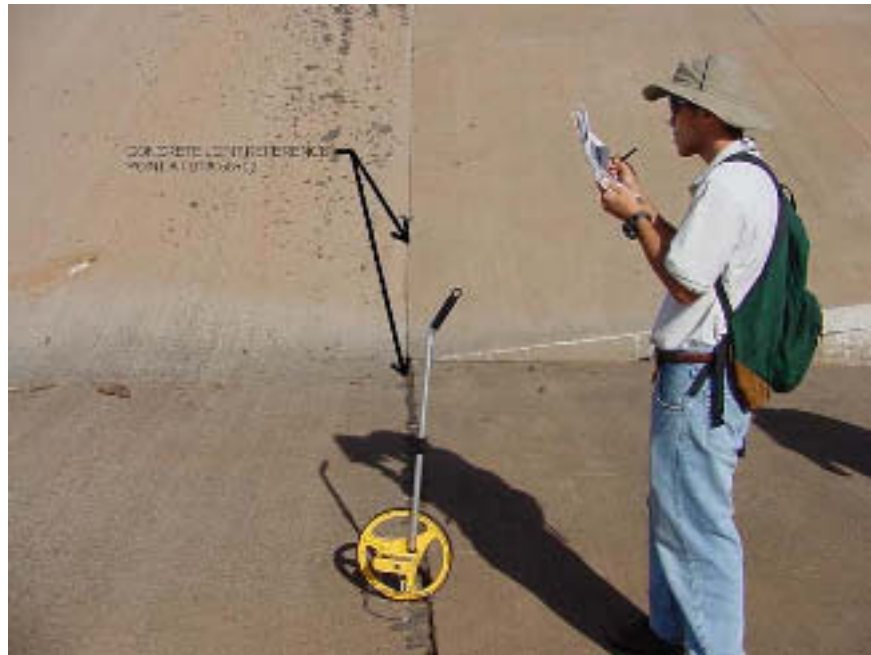
e. Sta. 53+02, concrete channel joint reference point.

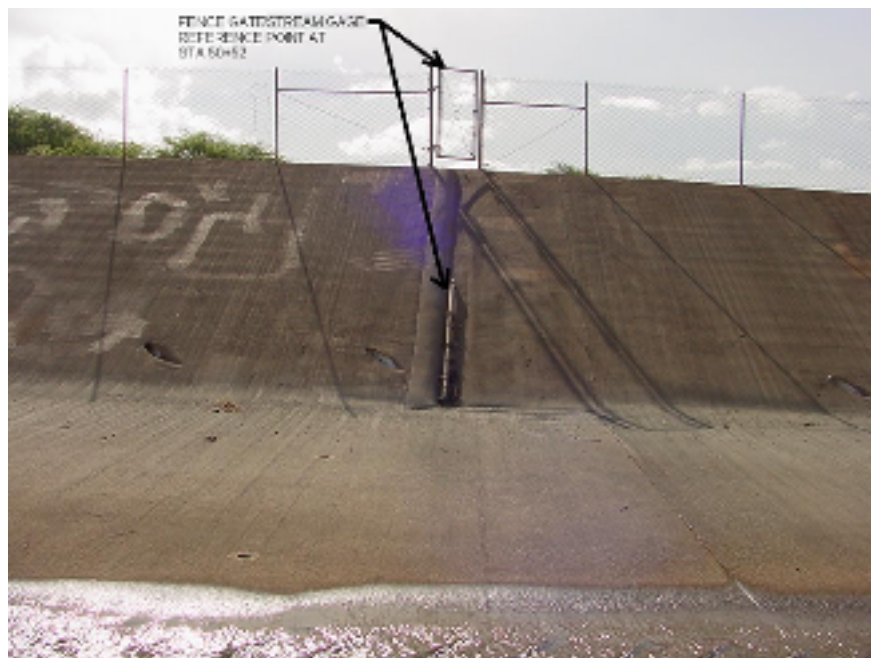
f. Sta. 50+52, Right Bank (RB), fence gate and stream gage reference point.

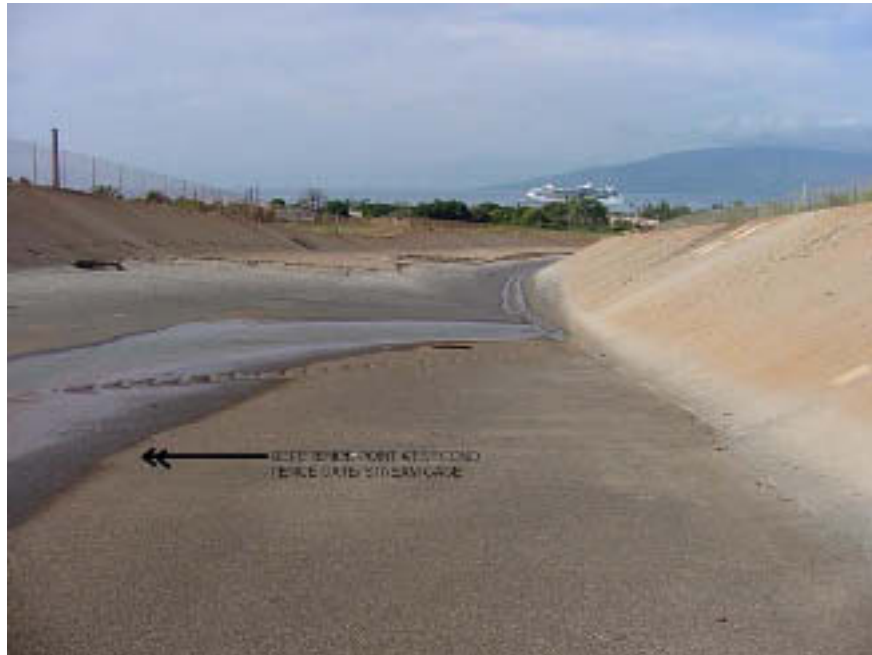
g. Sta. 49+00, Left Bank (LB), second stream gage and fence gate reference point.

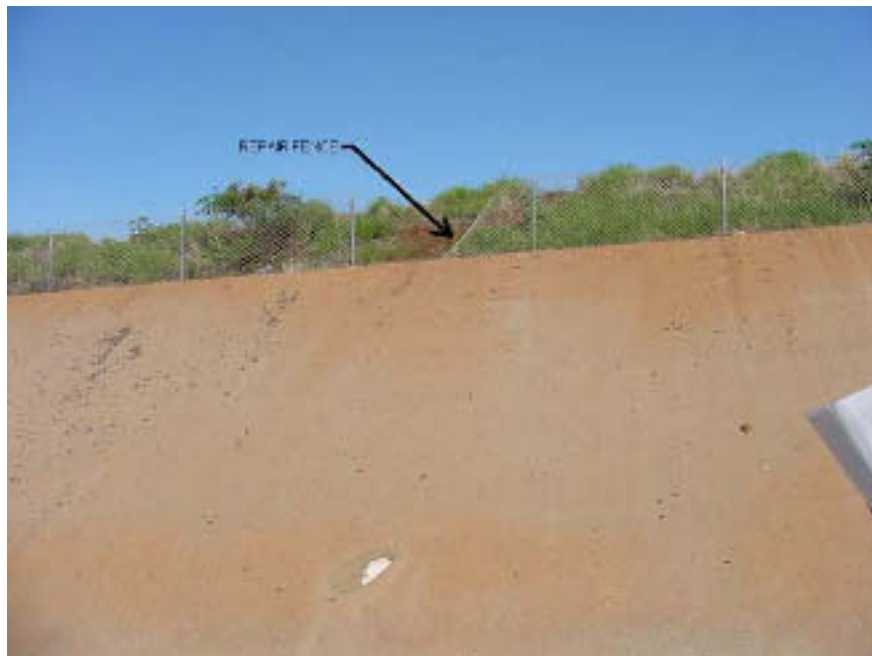
h. Sta. 48+55, RB, repair fence gate at chevron turn.

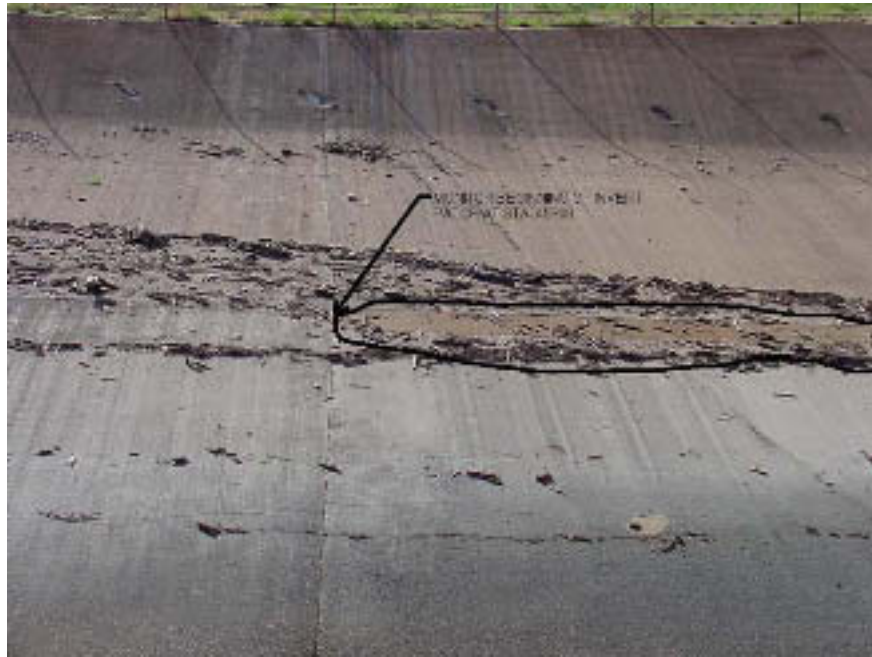
i. Sta. 45+00 to 42+49, channel, monitor hollow invert patch. Patch may have been a result of construction work to correct a late design change; moving grooved concrete swale.

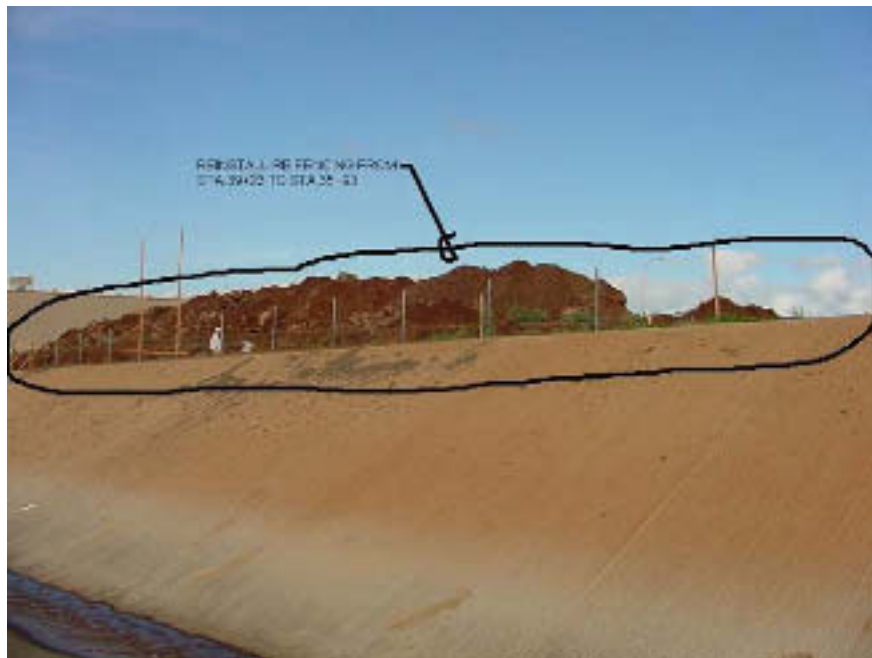
j. Sta. 39+23 to Sta. 35+93, RB, reinstall fencing as required.

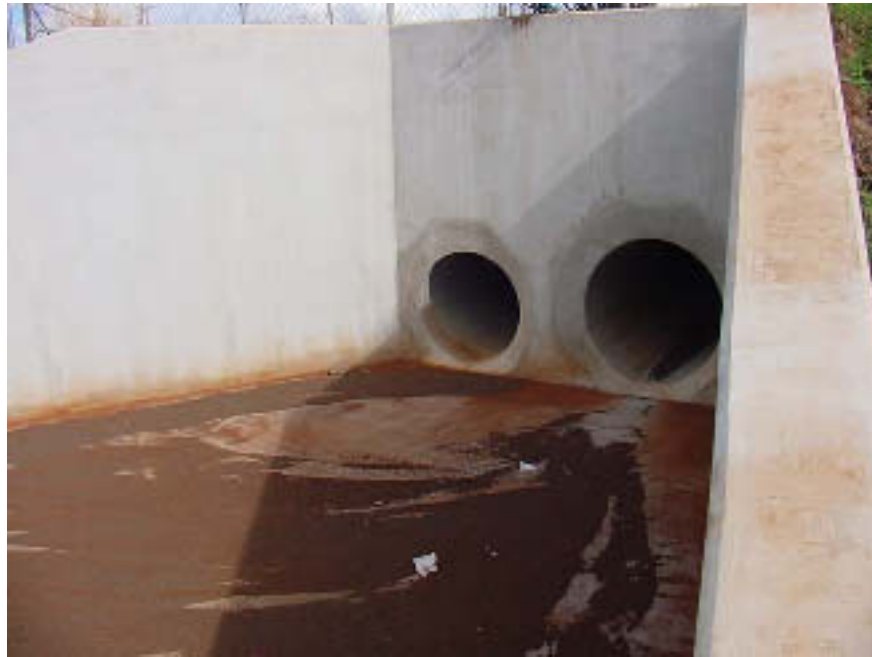
k. Sta. 26+00, RB, reference point of double drain pipes (RCP).

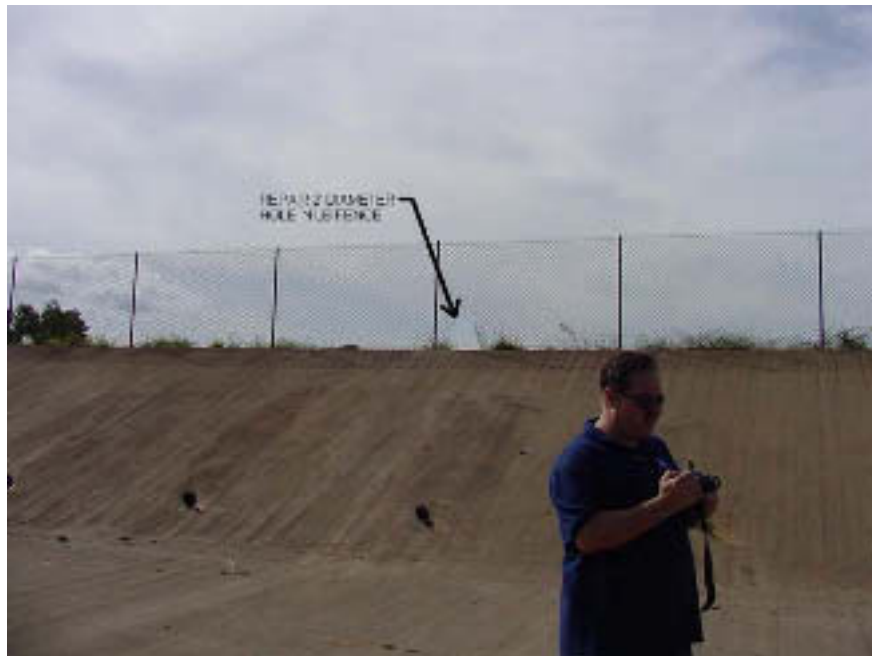
l. Approximate Sta. 11+50, LB, repair 2' diameter hole in fence.

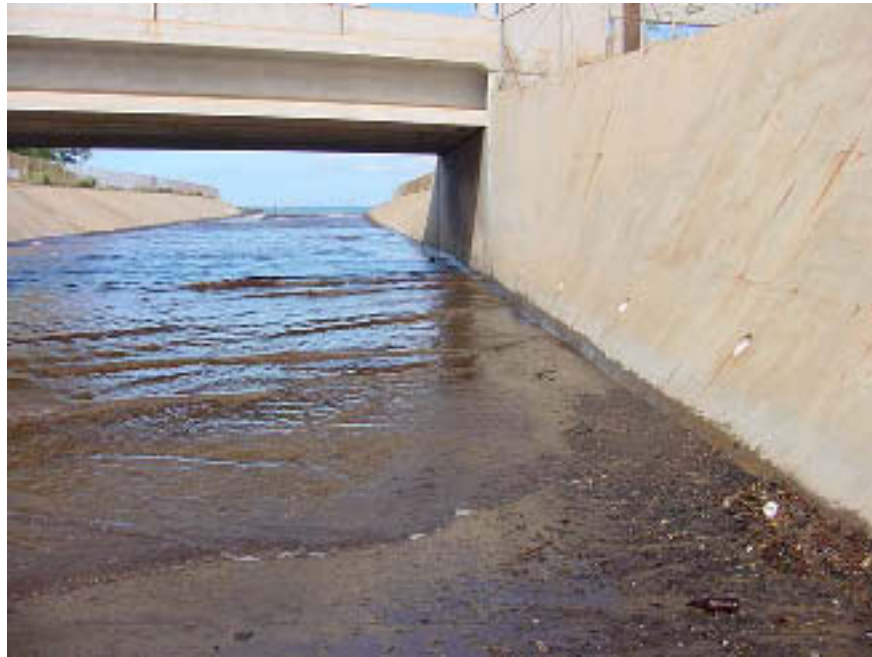
m1. Sta. 6+00, RB, patch invert of channel separation and monitor closely.

Repair settlement at Front Street Bridge Sta. 6+00 as described in pictures "m1" and "m2".

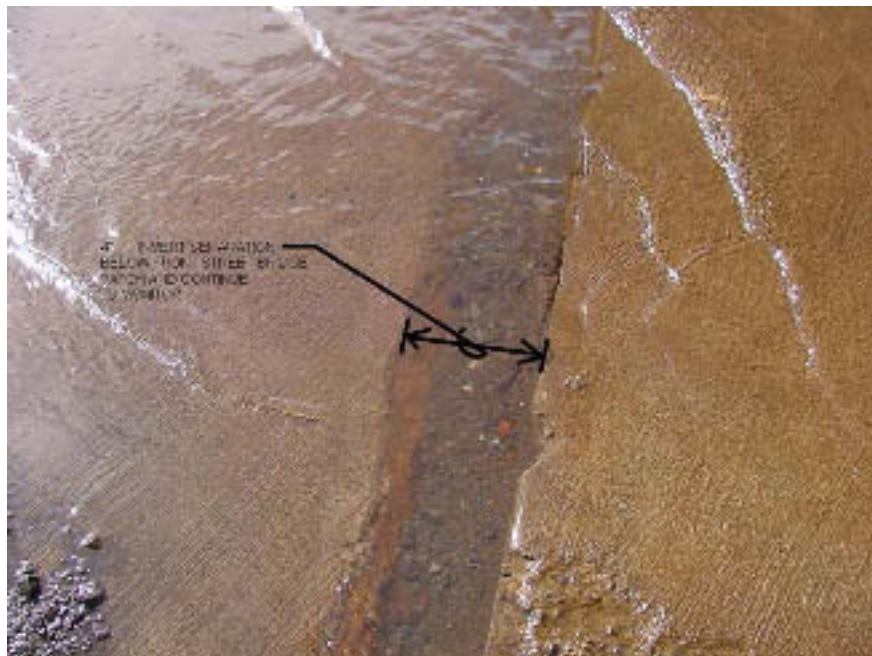
m2. Sta. 6+00, RB, close up view of 4" separation under the Front Street Bridge. Patch and monitor.

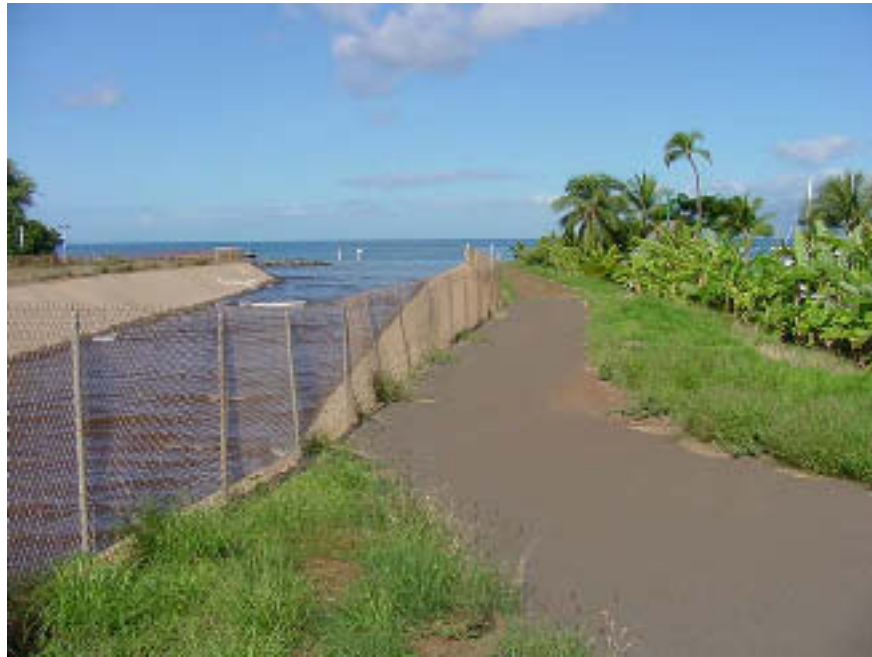
n. Approximate Sta. 3+50, overview of stream mouth.

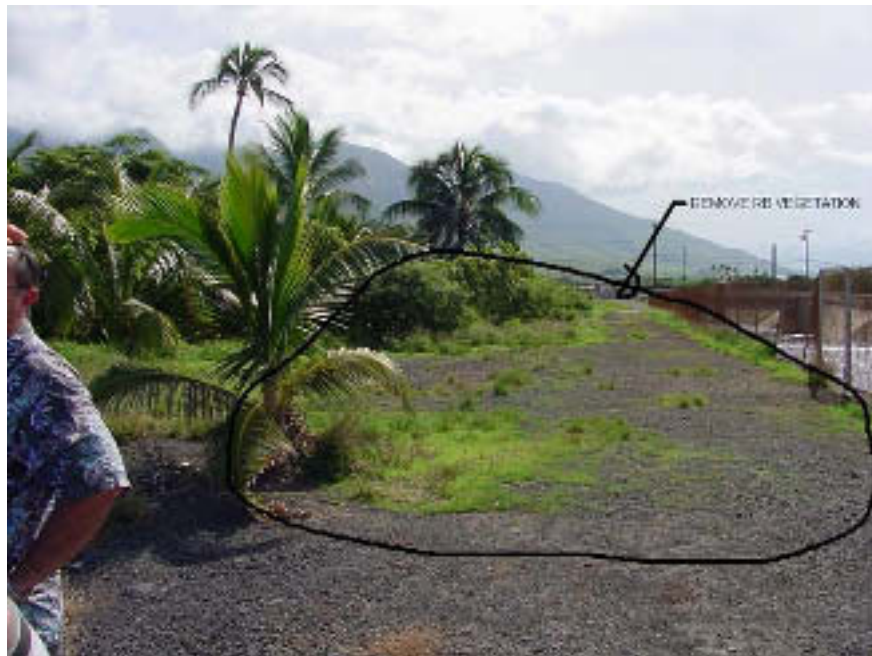
o. Approximate Sta. 1+50, RB, remove vegetation from top of bank and sideslope on townside.
